**PG&E Point Buchon Ocean Bottom Seismometer (OBS)  
Project, System Removal Biological Survey Report  
(September 8, 2015)**

September 8, 2015  
Project No. 1102-0621

Subject: PG&E Point Buchon Ocean Bottom Seismometer (OBS) Project, System Removal  
Biological Survey Report

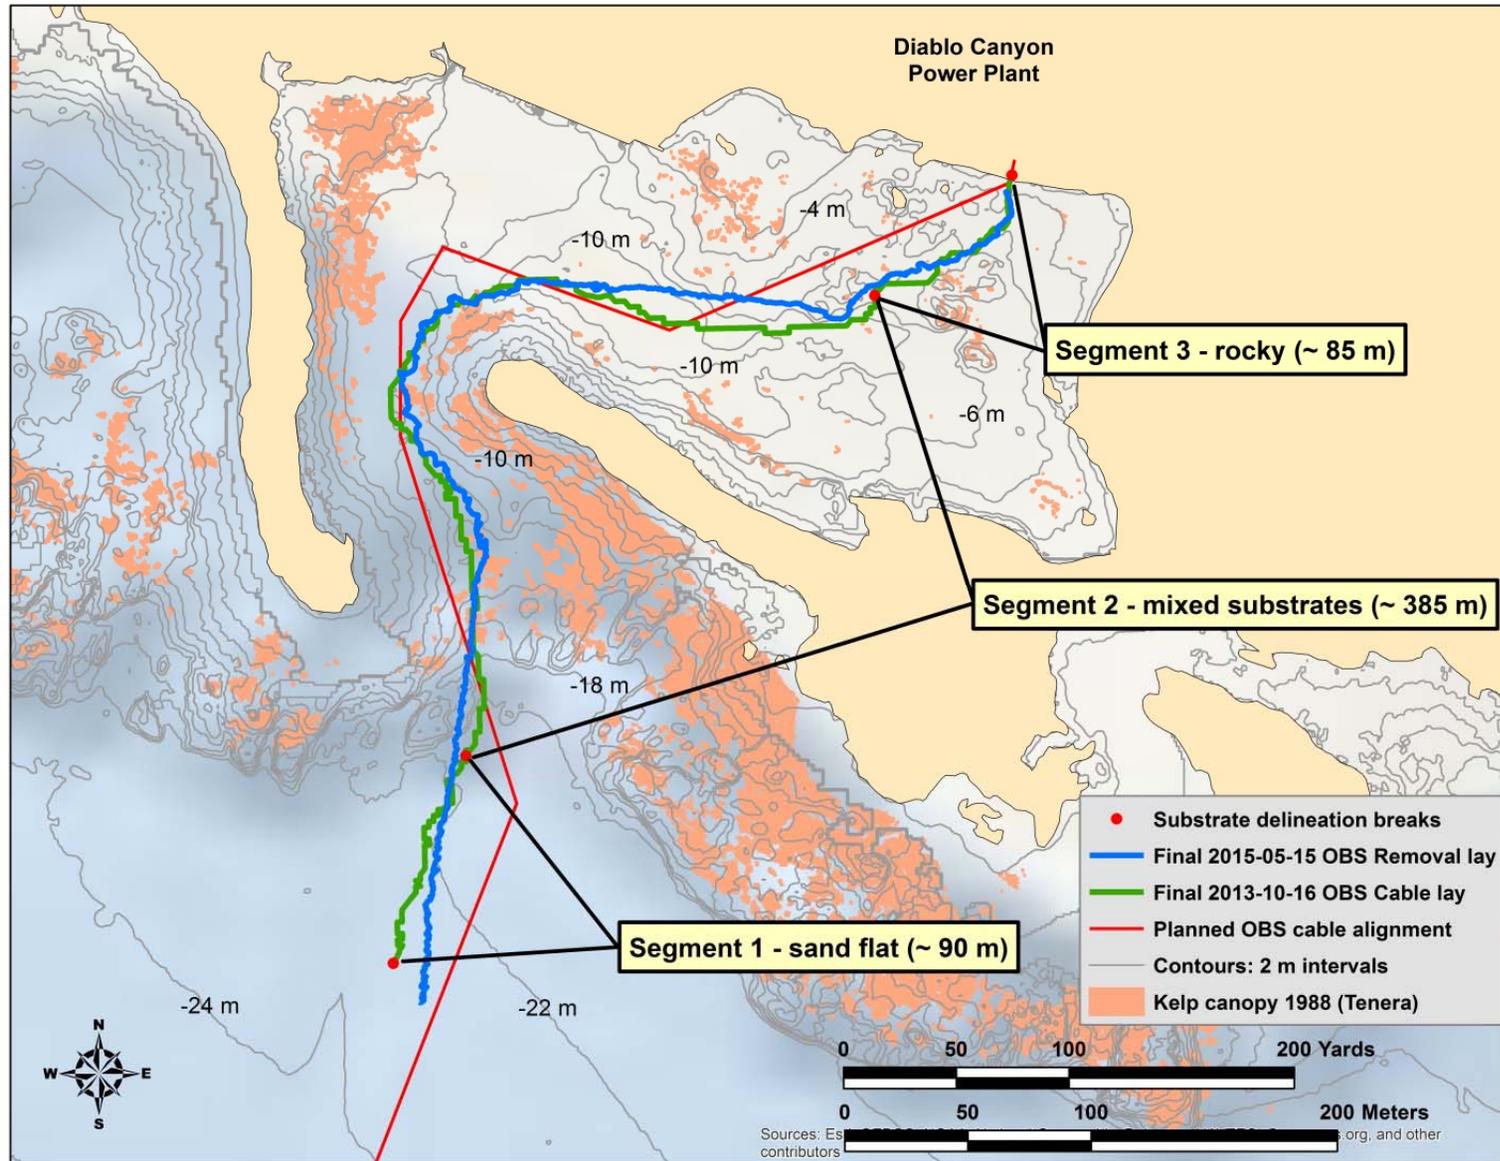
Figure 2. Diver Survey Location

The nearshore surveyed was approximately 1,837 ft- (560 m-) long, from the 76 ft (23 m) isobath to where the cable entered the PVC conduit along the shoreline of the DCPD intake embayment (Attachment A - Figure 2). The results of that survey indicated that seafloor habitats within the survey area consisted of sand flat, most common immediately seaward of the intake embayment; a mixture of bedrock, boulder, cobble, gravel, sand, common with the intake embayment; and bedrock reefs and boulders where the cable approaches the intertidal revetment and comes onshore.

There were no indications of habitats or biota having been impacted from the cable removal within the nearshore area. The cable remained relatively close to the as-built route and there were no observations of overturned rocks, damaged kelp (other than kelp attached to the cable itself), or injured or dislodged invertebrates. No remnant "trail" of the cable (depressions within the sediment) was observed, however divers did note a "furrow" through the *Diopatra* beds in one area where the sand flat transitioned into the mixed substrate; video of this furrow was recorded. No cable-associated impacts within the mixed substrate of bedrock and boulders were observed and no project-associated debris was observed in this segment.

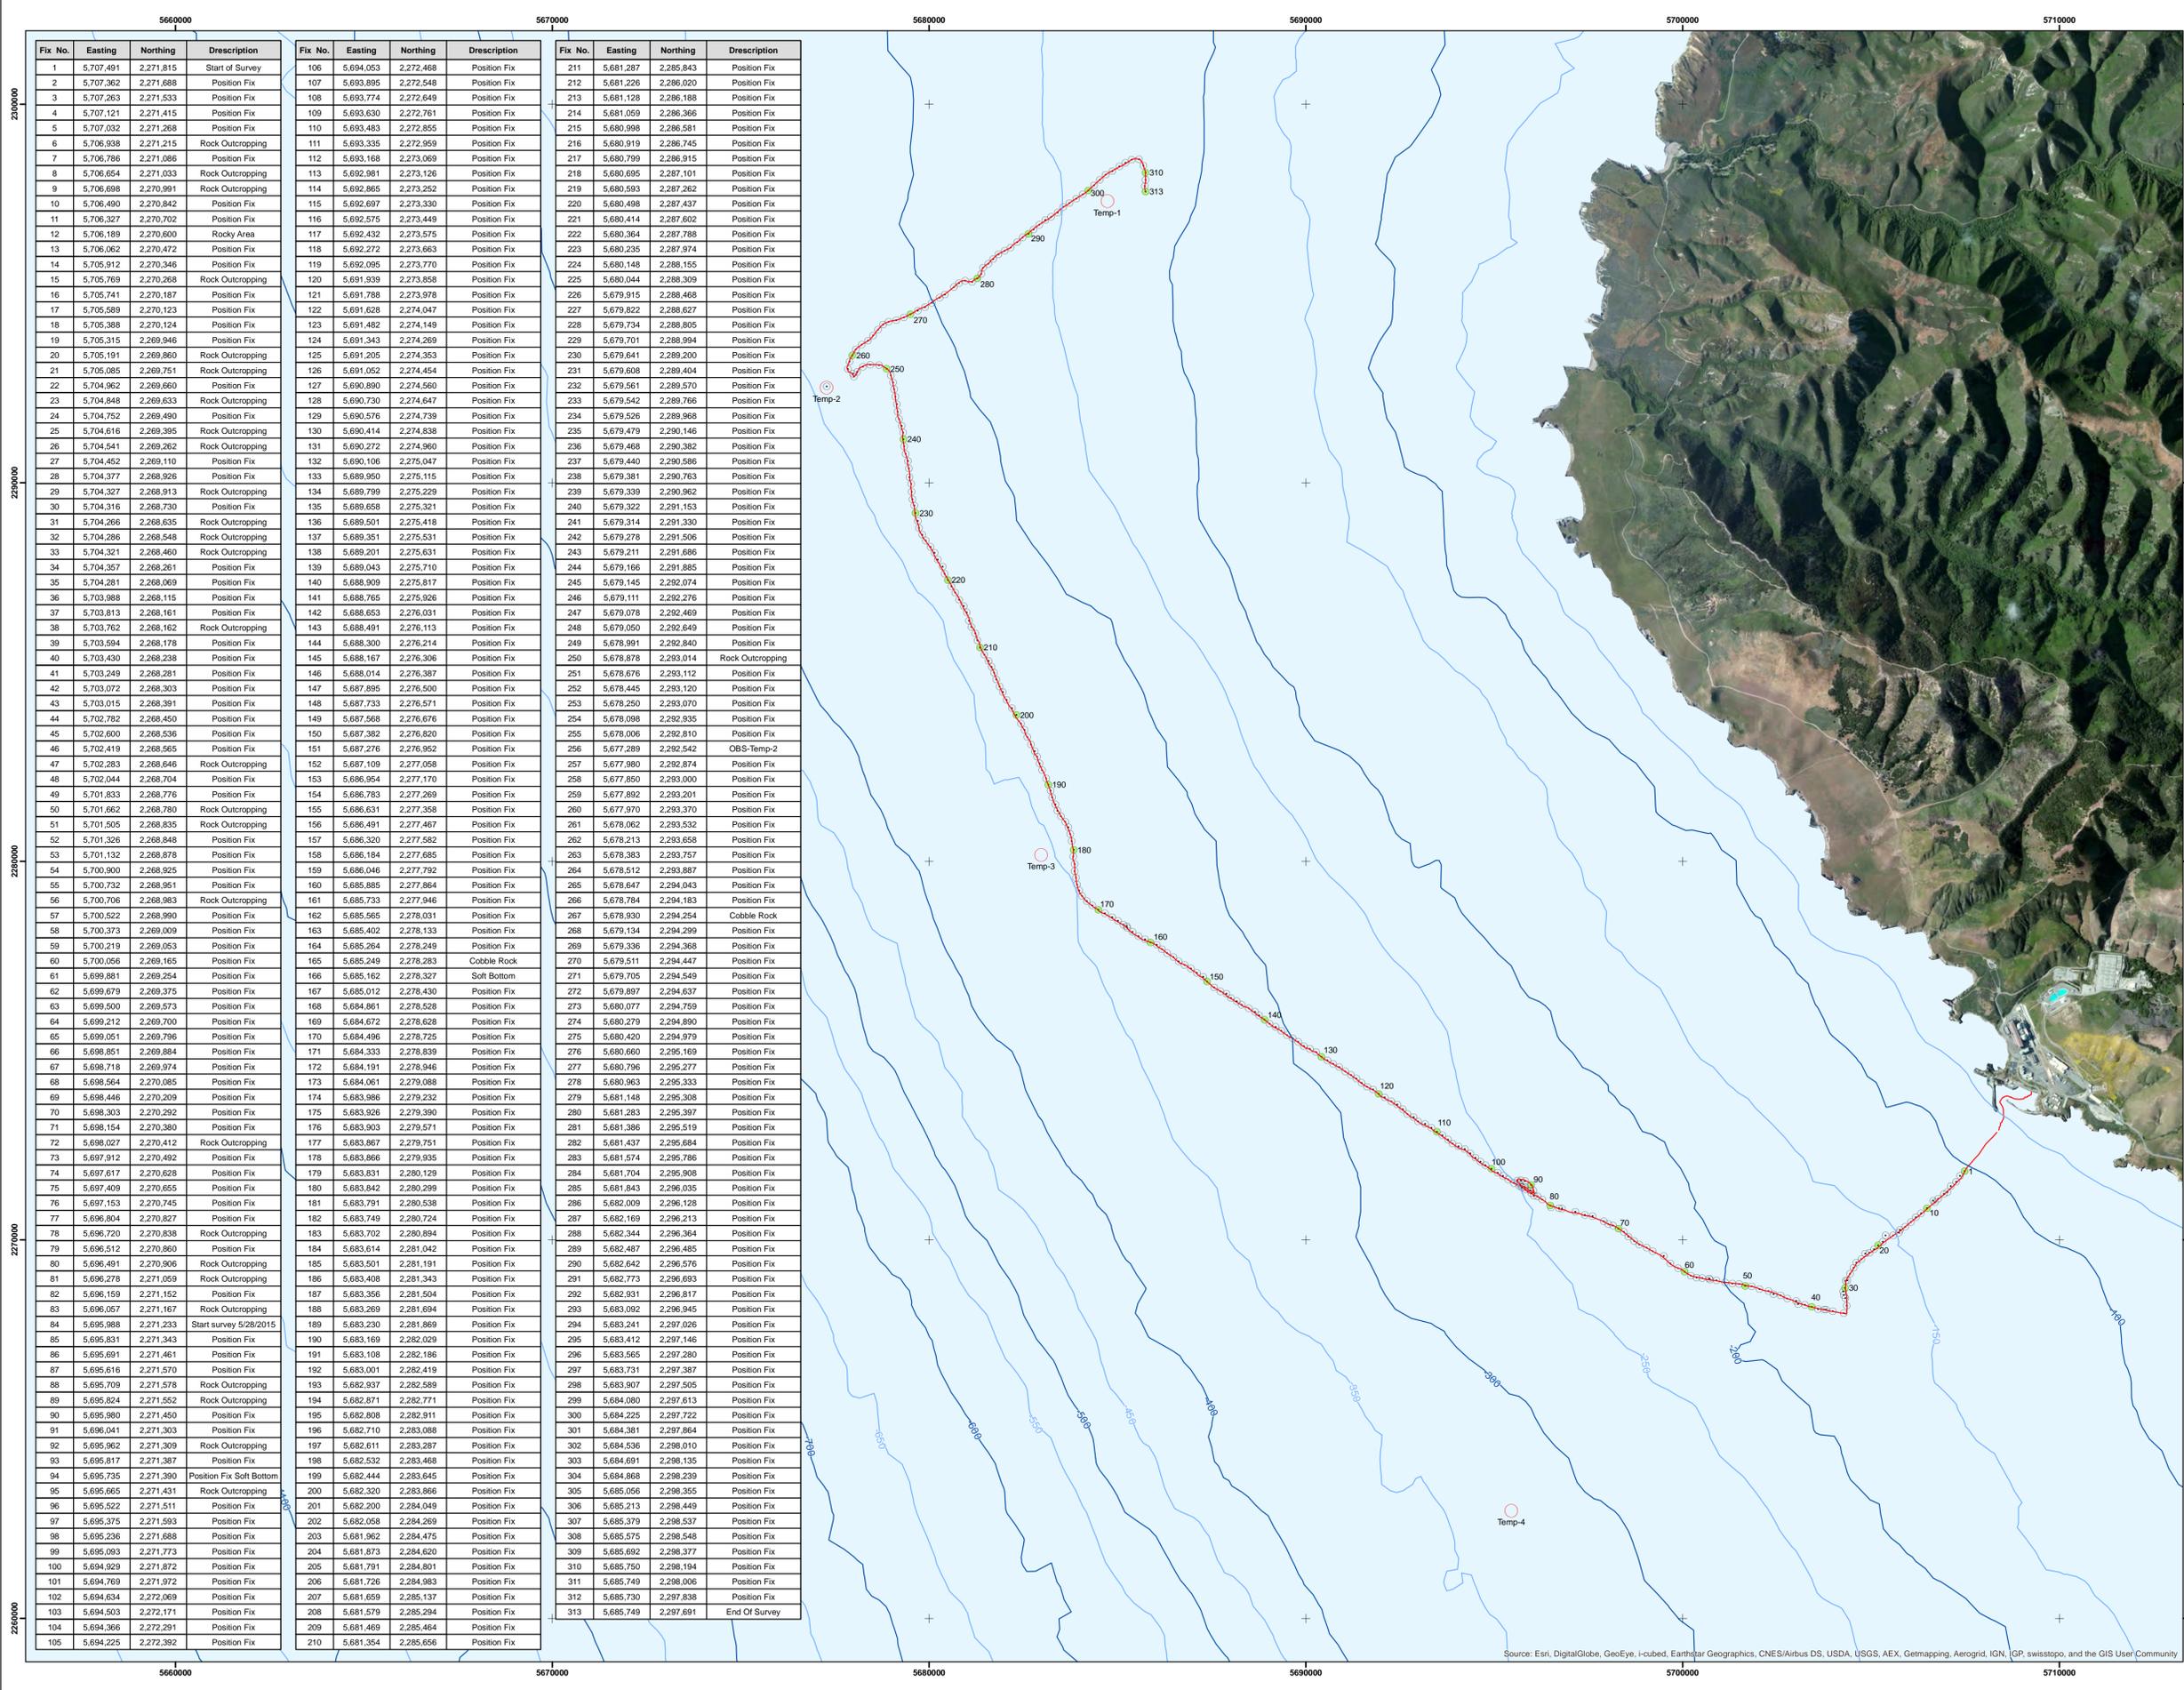
The ROV survey was initiated at the 100 ft (30 m) isobath. Approximately 11 hours of video was recorded within this segment (depth range 100 to 345 ft [30 and 105 m]) (Attachment A - Figure 3). Based on navigational post-plots, approximately 925 ft (282 m) of the cable was not observed by diver or ROV surveys. The 925 ft (282 m) segment was between the inshore most point of the ROV survey and the offshore terminus of the Tenera diver survey. The segment was within sedimentary habitat, and no debris, rock or other high-relief objects were observed on the scanning sonar image screen.

A depression at the long-term OBS-1 location was the only obvious seafloor alteration observed within this segment. That depression is estimated to be approximately six inches (in) (five centimeters [cm]) deep and approximately two feet (0.6 m) in diameter and had some shell hash. No other depressions, or trenching within the sedimentary substrates were observed in this segment, and no project-associated debris was observed within this segment.

A depression at the former long-term OBS-1 location and "furrow" through the *Diopatra* bed in the nearshore area were the only obvious seafloor alteration observed during both surveys. This depression and furrow is expected to "fill in" through natural sedimentation from the surrounding silty sediments and the area would be expected to support a fauna similar to that observed within these water depths within the project area. Other depressions in the deeper-water silty sedimentary substrate appear to be bioturbations (disturbances caused
